March 31, 2015

Re: 2015 Annual Report of Conditions – 183A Turnpike / Manor Expressway

**2015 Annual Report of Conditions
183A Turnpike – HNTB
Manor Expressway - Atkins**

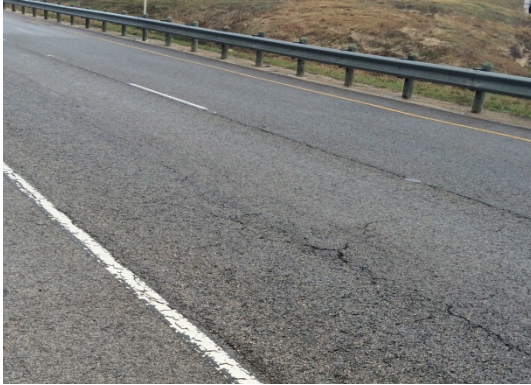
Observed Longitudinal Cracking

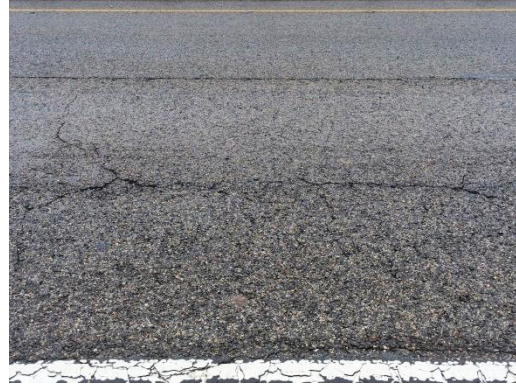
Observed Fatigue Cracking

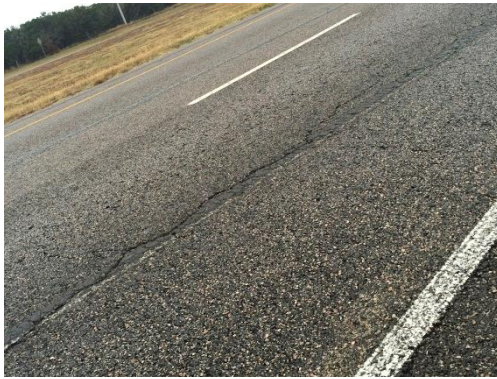
Observed Longitudinal Cracking

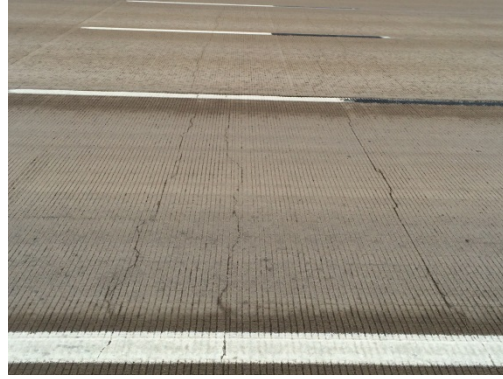
Observed Transverse Cracking

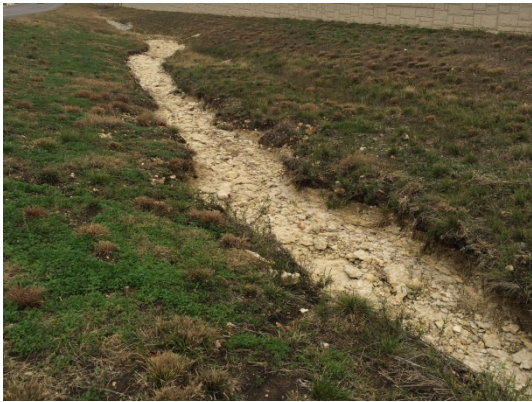
Drainage elements overall were found to be in good condition with only minor deficiencies. There was sediment buildup in some of the inlets. Minor to moderate erosion was present in several ditches and berms and at bridge drain outlets. Some examples are shown in the pictures below.

Erosion between SBML and SBFR

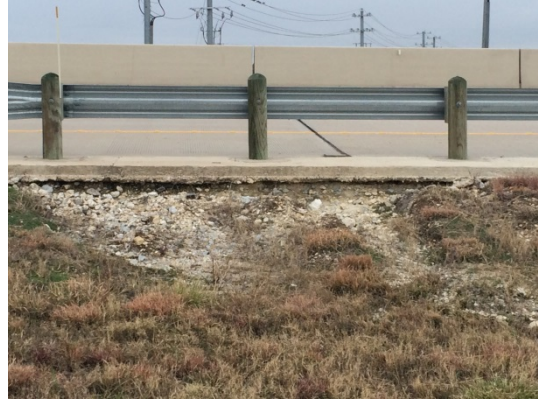
Erosion behind MBGR on SBML

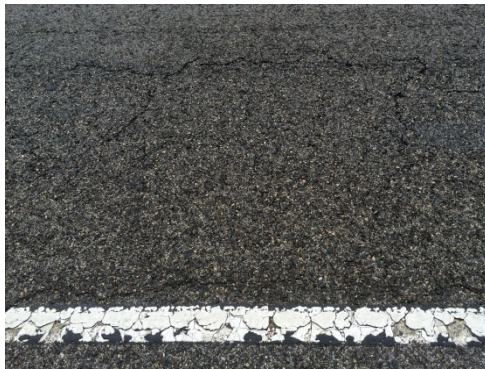
Observed Pavement Marking Cracking

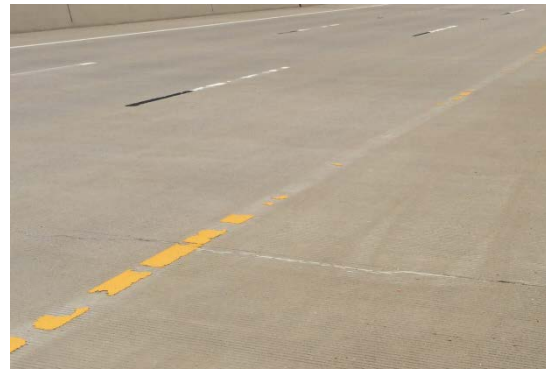
Observed Pavement Marking Fading

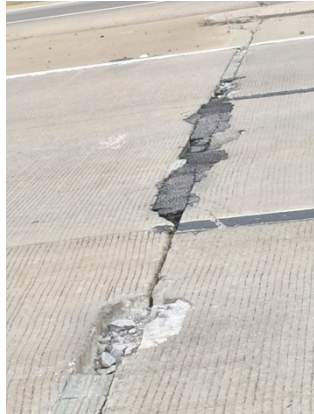
Southbound Mainlanes
North of RM 1431

Two small potholes were identified along the concrete pavement – one located on the southbound mainlane just north of RM 1431 and the other in the southbound entrance ramp at Brushy Creek Loop, just South of the toll gantry. These deficiencies may affect vehicles along 183A and should be repaired in a timely manner.

- Two potholes were identified in the concrete pavement of the southbound mainlanes and should be repaired in a timely manner (see pictures below). The first pothole is located just north of RM 1431 and the second can be found at the Brushy Creek Loop entrance ramp, just south of the toll gantry.

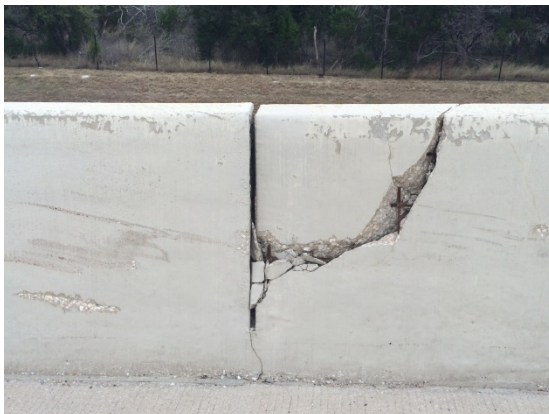
Northbound Mainlanes North of
Avery Ranch

- There is large break with exposed rebar in the Single Slope Traffic Rail (SSTR), located on the northbound mainlane, just north of Avery Ranch (see picture below).
- A large vertical crack in the SSTR, also on the northbound mainlane, can be found north of Park Street (see picture below). Although this damage is more detrimental to the visual appeal rather than the functionality of the SSTR, the structure should be repaired as part of facility maintenance.
