CENTRAL TEXAS
Regional Mobility Authority

ANNUAL REPORT
OF CONDITIONS

Prepared by:
ATKINS
General Engineering Consultant

Re: 2017 Annual Report of Conditions – 183A Toll Road and 290 Toll Road/Manor Expressway

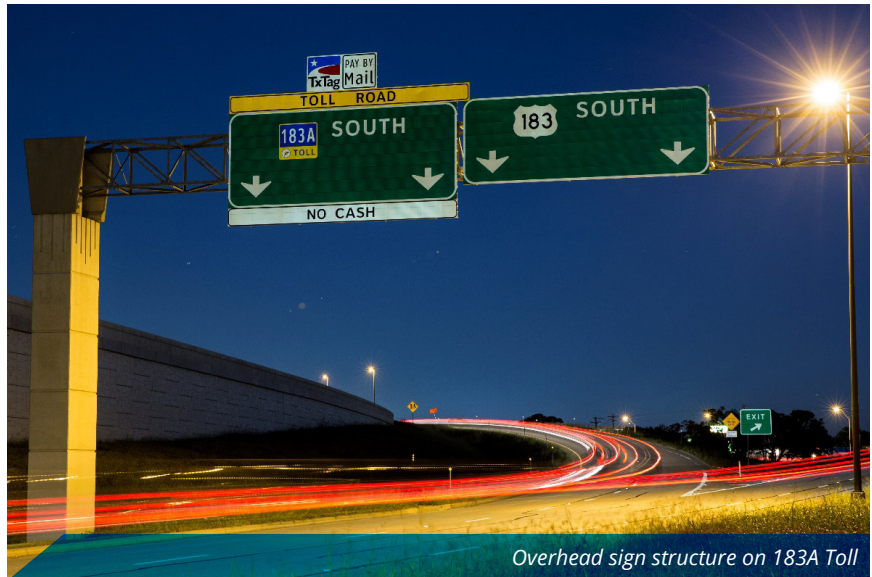
Overhead sign structure on 183A Toll

The inspection did not reveal any unsatisfactory deficiencies in the condition and operation of the toll gantries and sign structures.

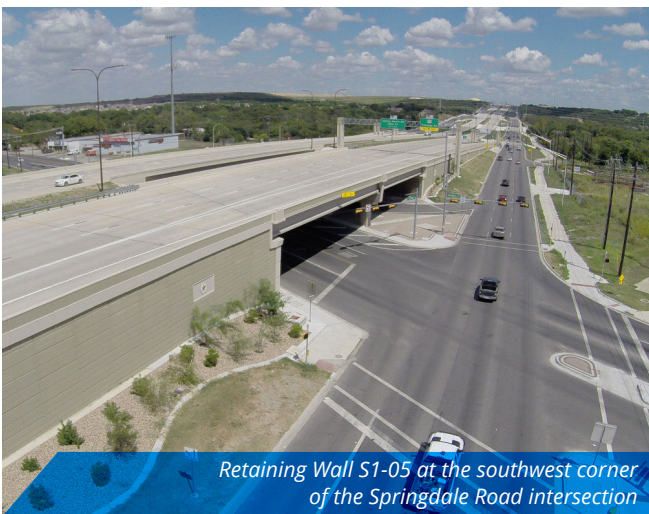
Retaining Wall S1-05 at the southwest corner of the Springdale Road intersection

The fall 2016 visual inspection did not identify any deficiencies that affect the safety and operations of the facility. The majority of the defects noted were vegetation growth causing minor drain obstruction and evidence of minor panel misalignment, as well

as unrelated panel spalling and cracking in other locations. However, last year's report indicated a significant number of vertical cracks on the wall panels of soil nail walls 19 and 20, at the Scottsdale Drive bridges, which had white, brown, or black stains at the crack. These drains have been located and cleaned. The structural integrity of the walls is not believed to be compromised; however the walls will continue to be monitored.

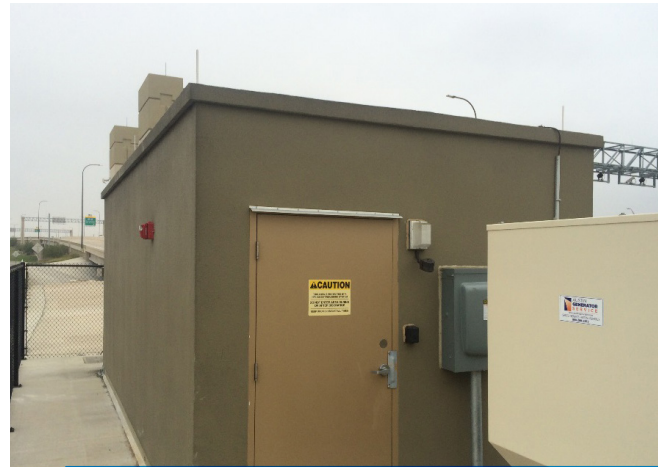
ILP building located at the Parmer Mainlane tolling location

The GEC was unable to gain access to the building interior at the mainlane Parmer ILP due to issues with the door hardware, therefore, this building was not inspected.

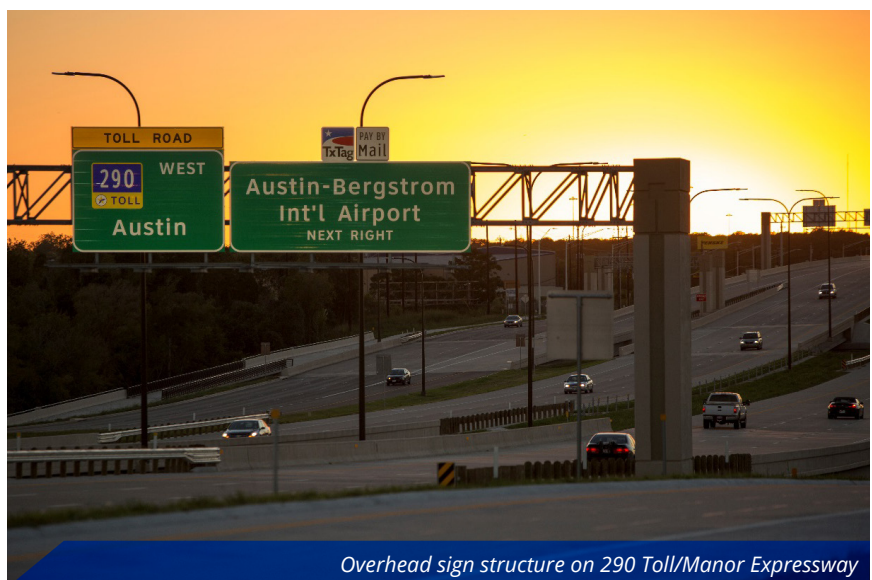
Overhead sign structure on 290 Toll/Manor Expressway

The inspection did not reveal any unsatisfactory deficiencies in the condition and operation of the toll gantries and sign structures.

Deficiencies requiring maintenance include members of a column support beginning to reveal rust stains from the presence of an iron ore aggregate which can occur naturally in the concrete coarse aggregate known as marcasite. These rust stains are limited to a cosmetic concern and are easily repaired. The Mobility Authority is monitoring this condition and will pursue cosmetic repairs through the PBMC.

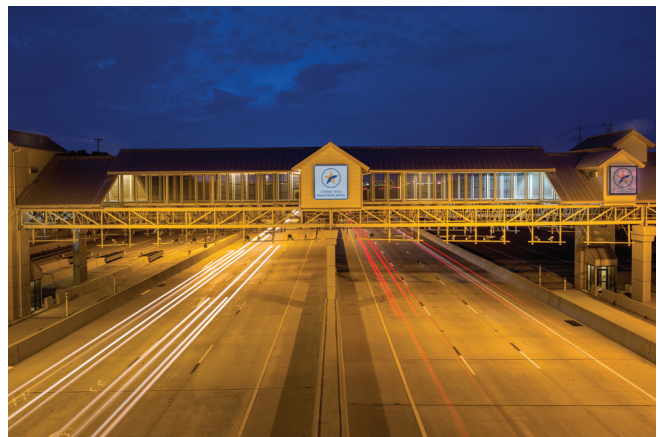
Pavement markings and graphics are showing significant signs of wear and warrant replacement. Raised pavement markings are in need of maintenance as well. This work is part of the PBMC scope and will be scheduled accordingly.

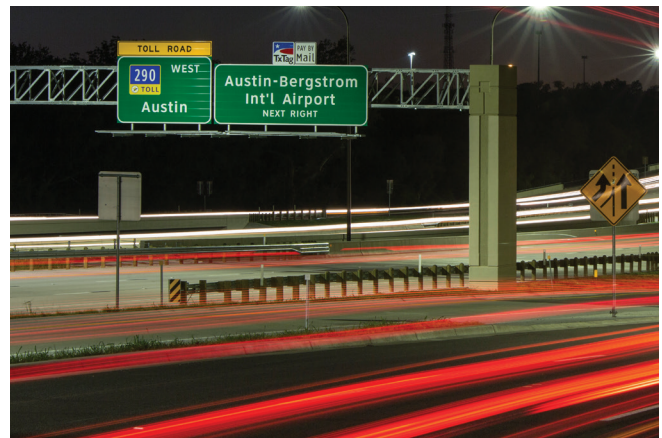
Pavement markings and graphics are showing significant signs of wear and warrant replacement. Raised pavement markings are in need of maintenance, as well. This work is part of the PBMC scope and will be scheduled accordingly.
