CENTRAL TEXAS REGIONAL  
MOBILITY AUTHORITY

# 2018 ANNUAL REPORT OF CONDITIONS

**Re: 2018 Annual Report of Conditions - 183A Turnpike, Manor Expressway, and SH 71 Express**

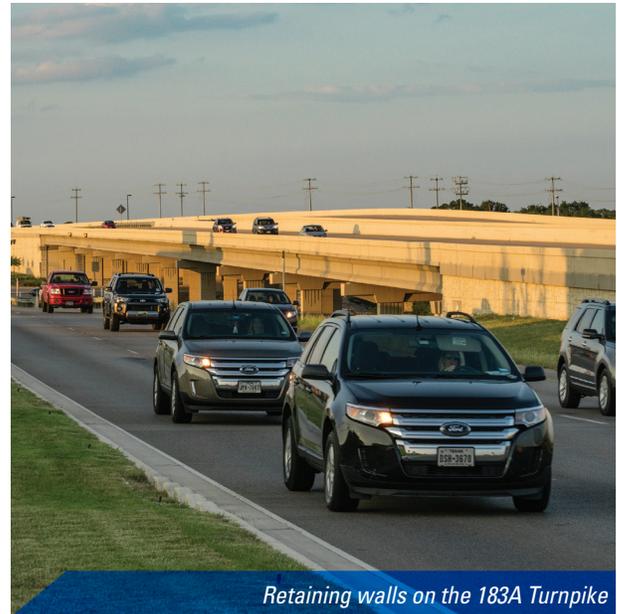
minor cracking of panels, minor scratches and chips at the bottom of the walls, believed to be from mowing operations and minor concrete riprap settlement.

*Retaining walls on the 183A Turnpike*

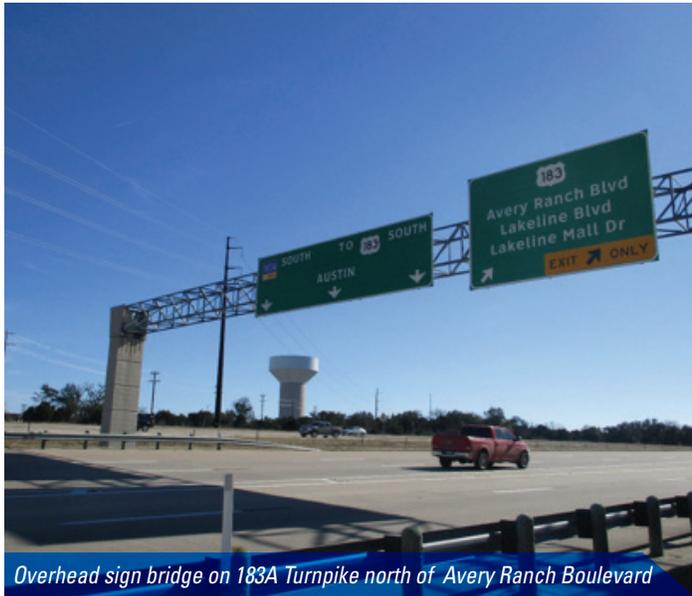
*Overhead sign bridge on 183A Turnpike north of Avery Ranch Boulevard*

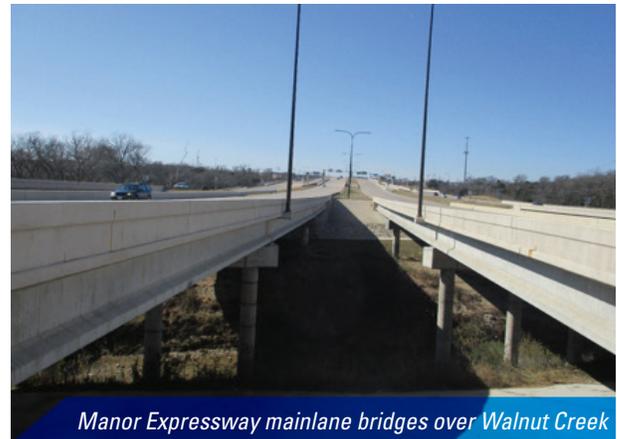
Based on a review of the most recent inspection reports and visual observations, Manor Expressway bridges are in adequate or better condition.

*Manor Expressway mainline bridges over Walnut Creek*

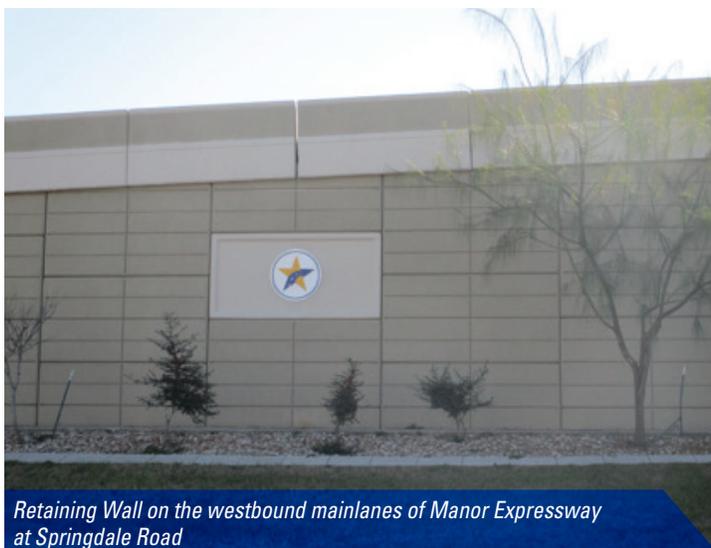
*Retaining Wall on the westbound mainlanes of Manor Expressway at Springdale Road*

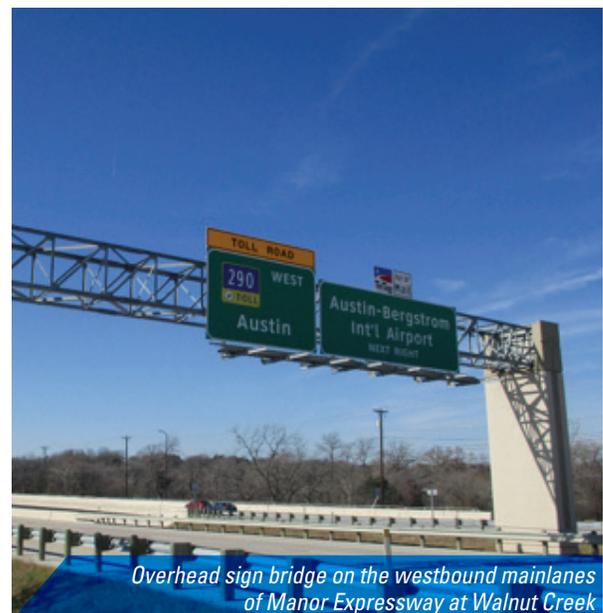
The inspection did not reveal any unsatisfactory deficiencies in the condition or operation of the toll gantries and sign structures. Deficiencies requiring maintenance include members of a column support beginning to reveal rust stains from the presence of an iron ore aggregate which can occur naturally in the concrete coarse aggregate known as marcasite. These rust stains are limited to a cosmetic concern and are easily repaired. The Mobility Authority is monitoring this condition and will pursue cosmetic repairs through the PBMC.

*Overhead sign bridge on the westbound mainlanes of Manor Expressway at Walnut Creek*

Minor cracking was also observed. While cracking is common with concrete, it is a relatively minor issue and does not affect safety and operations at this time. This issue does not require immediate attention; however it should continue to be monitored during future condition inspections.

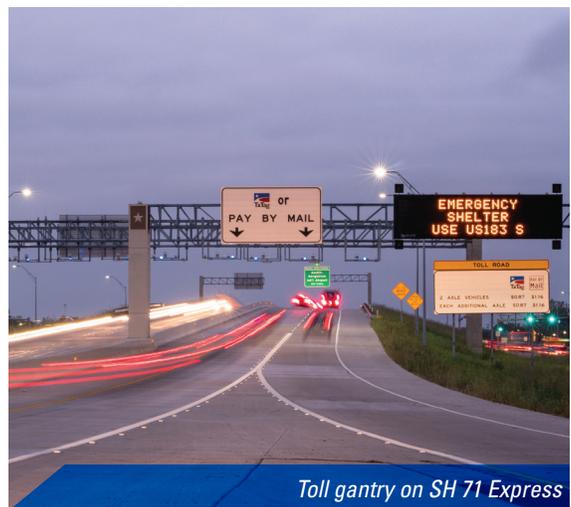
Toll gantry on SH 71 Express

The visual inspection of the toll system infrastructure indicates that the primary components remain in very good condition. Efforts should be made to continue to keep all components clean, well maintained, and secure for the TCS.
