March 31, 2015

Re: 2015 Annual Report of Conditions – 183A Turnpike / Manor Expressway

**2015 Annual Report of Conditions
183A Turnpike – HNTB
Manor Expressway - Atkins**

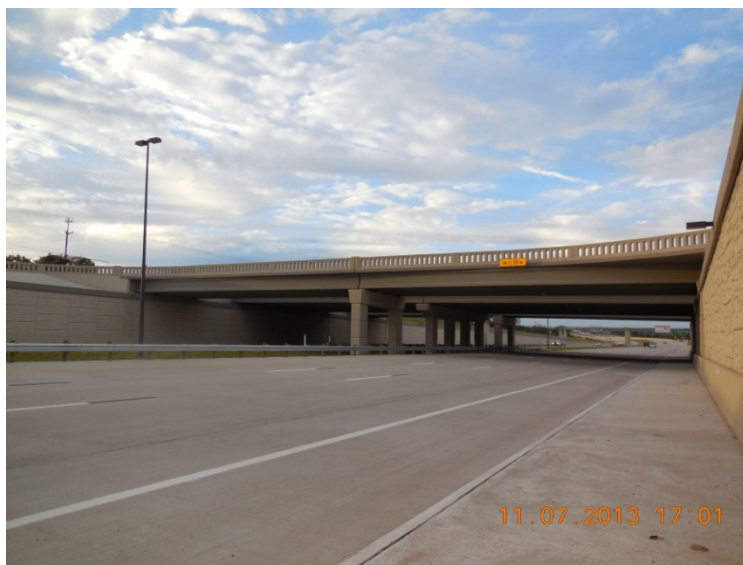
Scottsdale bridge over Mainlanes

Based on a review of the most recent inspection reports and visual observations, 183A bridges, including those for the shared use path, remain in good condition. There are no significant deficiencies noted in the 2013 and 2014 NBIP Reports.

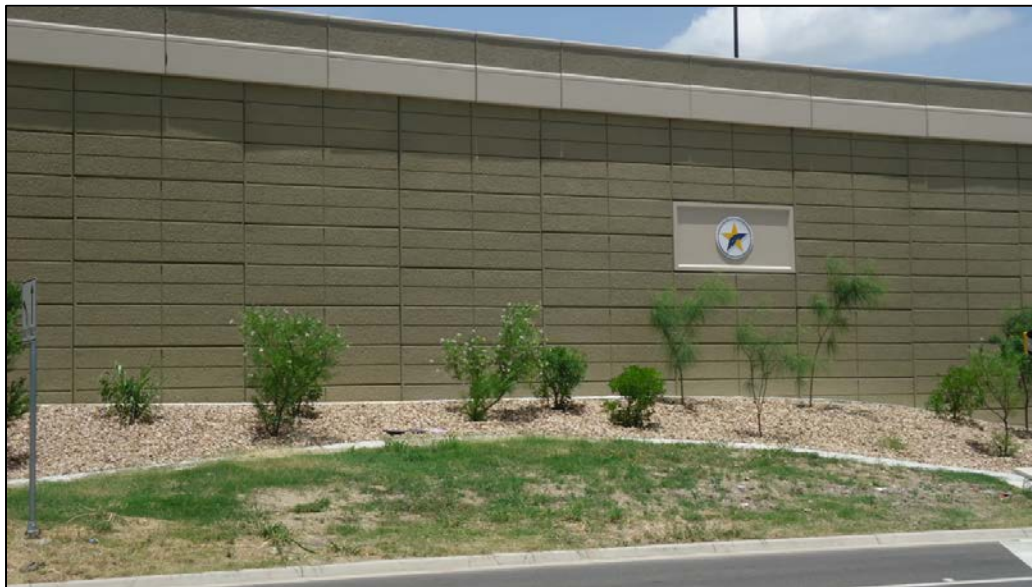
Retaining wall along the eastbound Manor Expressway west of Springdale Road

Based on visual observations, both new and existing retaining walls on the Manor Expressway project are in very good condition. There were minor deficiencies noted during the inspection such as minor scratches to the panels. The scratches to the panels are not considered structurally deficient. A list of deficiencies is being provided to the Mobility Authority to forward to either the PBMC maintenance contractor to be addressed.

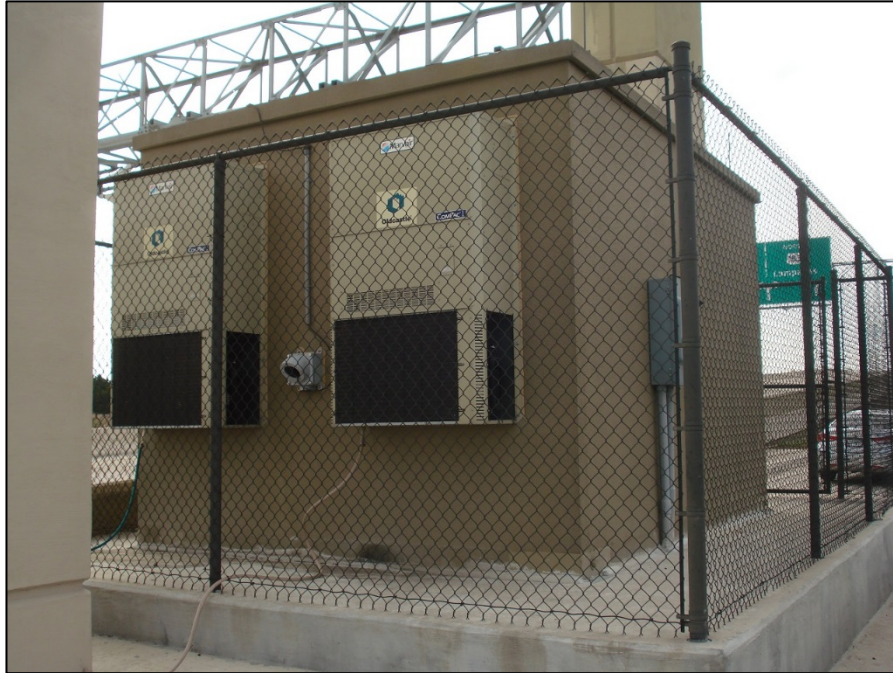
ILP building located at the WNDC toll location

A summary of the Mobility Authority’s ILP buildings and the associated general conditions are described in the Manor Expressway Inspection Report. Overall, the ILP building facilities on Manor Expressway are in very good condition. The following is a general summary of condition assessment for each category.

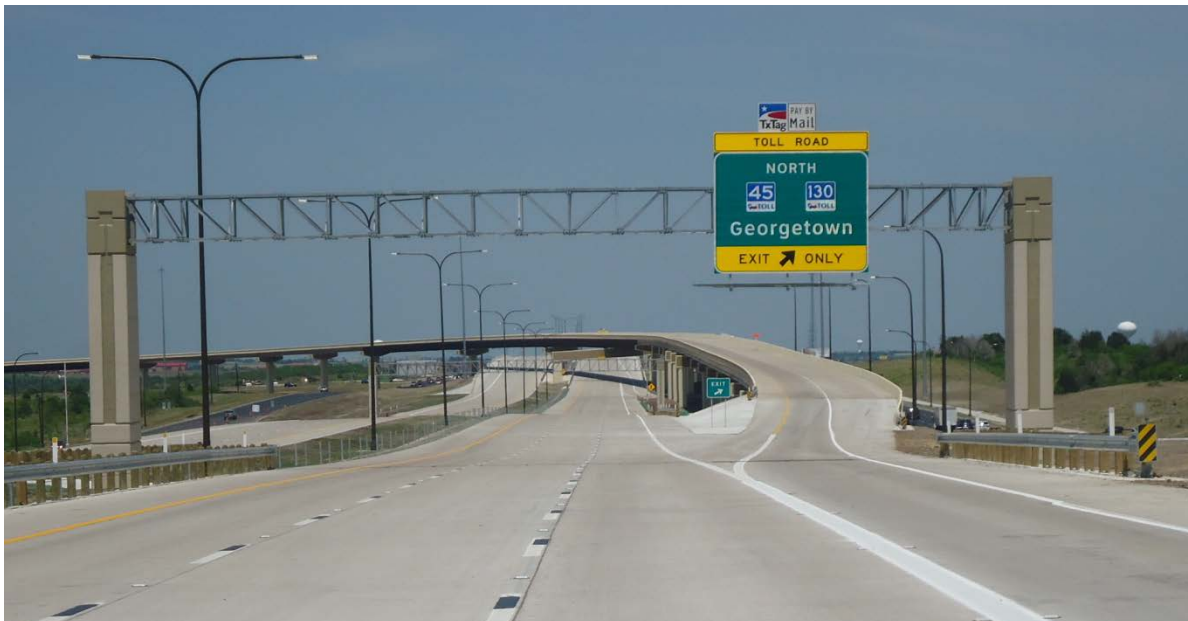
Overhead sign structure eastbound approaching SH 130

The inspection did not reveal any major deficiencies in the condition and operation of the toll gantries and sign structures. Minor deficiencies, including members of a column support have begun to rust in areas where the galvanized finish has been rubbed.

The inspection did not reveal any major deficiencies in the condition and operation of the toll gantries and sign structures. Minor deficiencies, including members of a column support have begun to rust in areas where the galvanized finish has been rubbed. A list of deficiencies is being provided to the Mobility Authority to forward to the PBMC maintenance contractor to be addressed.
