CENTRAL TEXAS
Regional Mobility Authority

ANNUAL REPORT
OF CONDITIONS

Prepared by:
ATKINS
General Engineering Consultant

Re: 2017 Annual Report of Conditions – 183A Toll Road and 290 Toll Road/Manor Expressway

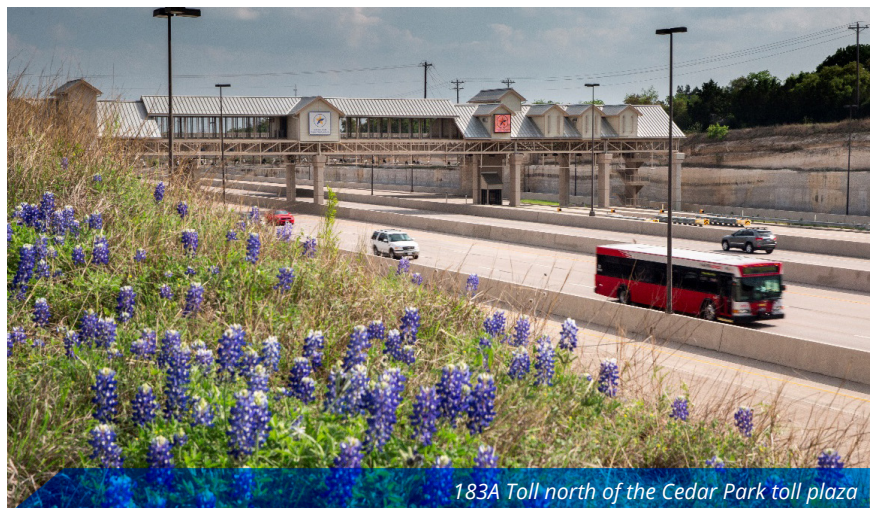
Although minor issues were noted, the inspection conducted in October 2016 did not identify any major deficiencies in the asphalt pavement that affect the safety and operations of 183A. It should be noted that the northbound and southbound frontage roads from RM 1431 to approximately 1000

183A Toll north of the Cedar Park toll plaza

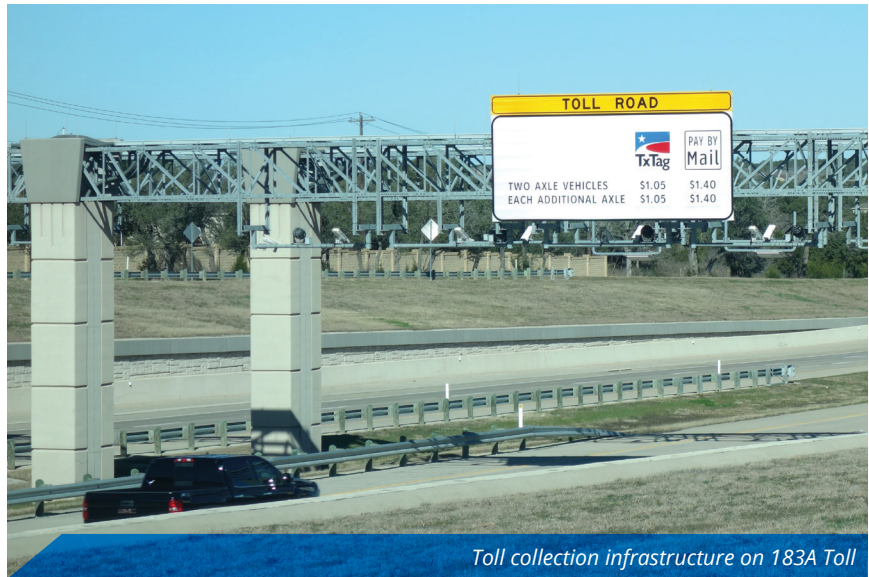
As discussed in Section 2.2.4 (Buildings), the visual inspection of the building and civil site aspects of the toll system infrastructure indicates that the primary components are in adequate or better condition. In addition, as discussed in Section 2.2.6 (Overhead Sign Bridges), the toll gantries are in adequate or better condition. Other elements associated with the toll infrastructure listed above were found to be in adequate or better condition. Efforts should be made to continue to keep all components clean, well maintained, and secure for the TCS.

Toll collection infrastructure on 183A Toll

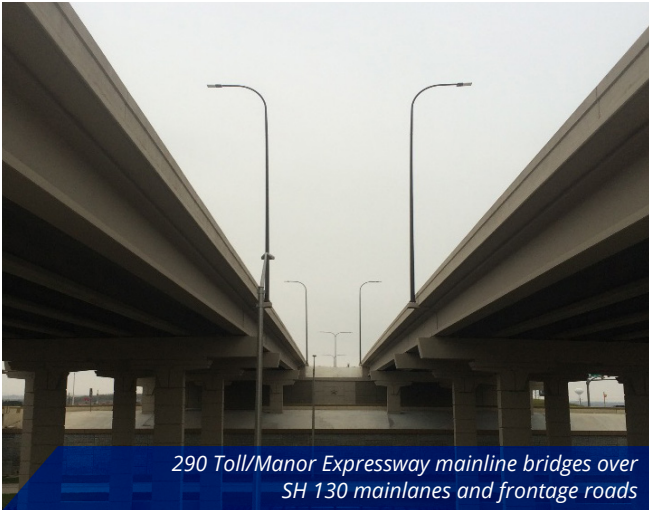
Based on a review of the most recent inspection reports and visual observations, 290 Toll/Manor Expressway bridges are in adequate or better condition.

290 Toll/Manor Expressway mainline bridges over SH 130 mainlanes and frontage roads

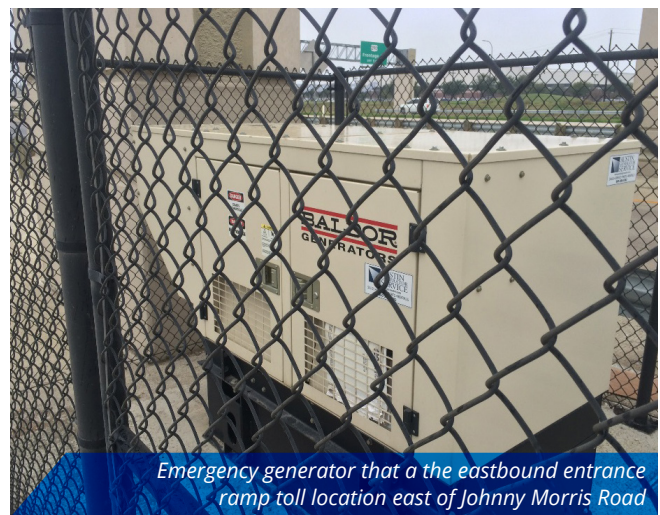
Emergency generator that a the eastbound entrance ramp toll location east of Johnny Morris Road

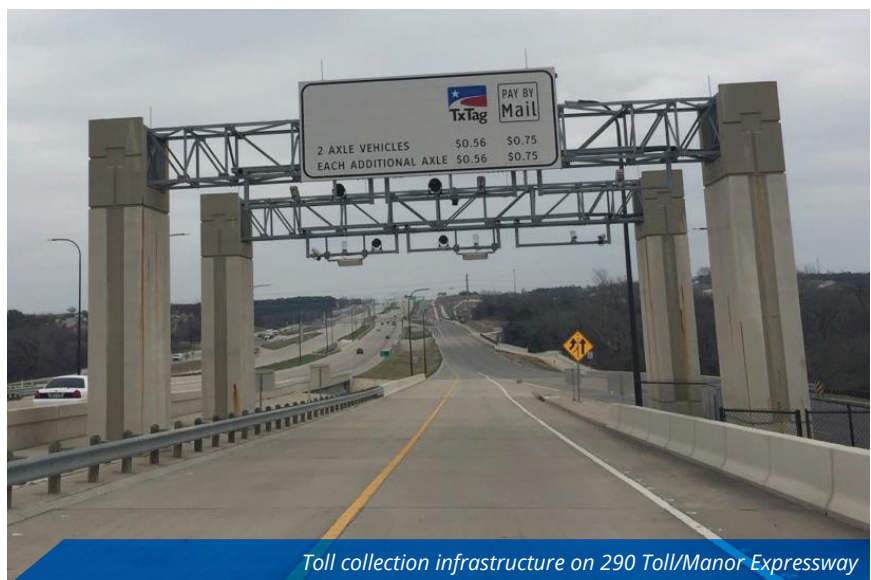
As discussed in Section 2.3.4 (Buildings), the visual inspection of the building and civil site aspects of the toll system infrastructure indicates that the primary components are in adequate or better condition. In addition, as discussed in Section 2.3.6 (Overhead Sign Bridges), the toll gantries are in adequate or better condition. Other elements associated with the toll infrastructure listed above were found to be in adequate or better condition. Efforts should be made to continue to keep all components clean, well maintained, and secure for the TCS.

Toll collection infrastructure on 290 Toll/Manor Expressway
