CENTRAL TEXAS REGIONAL  
MOBILITY AUTHORITY

# 2018 ANNUAL REPORT OF CONDITIONS

**Re: 2018 Annual Report of Conditions - 183A Turnpike, Manor Expressway, and SH 71 Express**

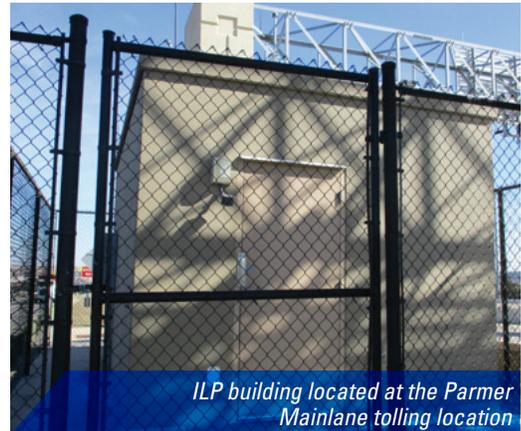
No deficiencies requiring maintenance were observed on the mechanical systems at either ILP building.

*ILP building located at the Parmer Mainlane tolling location*

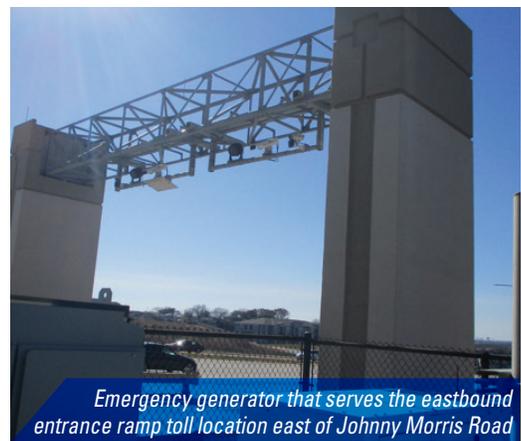
*Emergency generator that serves the eastbound entrance ramp toll location east of Johnny Morris Road*
