CENTRAL TEXAS REGIONAL
MOBILITY AUTHORITY

ANNUAL REPORT OF CONDITIONS

CENTRAL TEXAS REGIONAL MOBILITY AUTHORITY SYSTEM

Subject: 2024 Annual Report of Conditions - 183A Turnpike, 290E, SH 71 Express, SH 45 Southwest, 183 South, 183A Phase III Project, 183 North Mobility Project

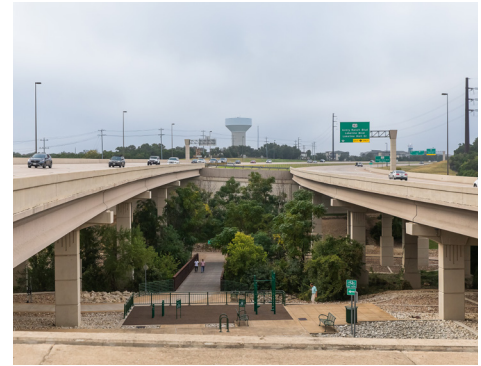
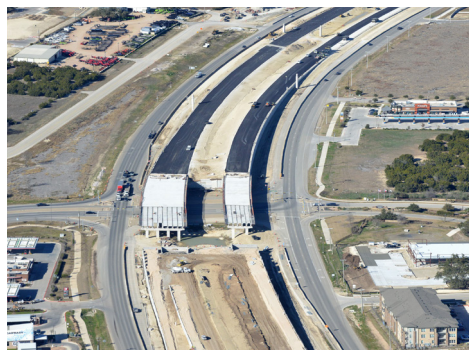
1.3.1. 183A TURNPIKE

The Mobility Authority constructed, operates and maintains the 183A Turnpike, a tolled facility stretching 11.6 miles from RM 620 to Hero Way in Williamson County. The corridor is a critical link in the highway network serving an area experiencing tremendous development and economic growth. The Project included phased construction with Phase I opening in 2007, Phase II opening in 2012, and intersection improvements opening in 2015 effectively reducing congestion, enhancing mobility, and providing safer travel and better access to developments along the corridor. Additionally, the project includes 6.9 miles of shared use path and connections to regional trails.

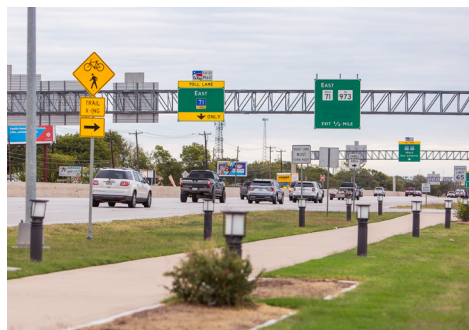
1.3.3. 290E

The Mobility Authority constructed, operates, and maintains the 290E, a toll road along US 290 from US 183 to just east of Parmer Lane with 7.3 miles of improvements. It includes three tolled mainlanes and three non-tolled general-purpose lanes in each direction, direct connectors (DCs) to US 183 and SH 130, and a 6.3-mile shared use path along the entire corridor. The corridor is a significant link to important roadways in the region including US 183, IH-35 and SH 130, and , effectively reduced congestion on US 290 and provides reliable travel times for tolled and non-tolled travel.

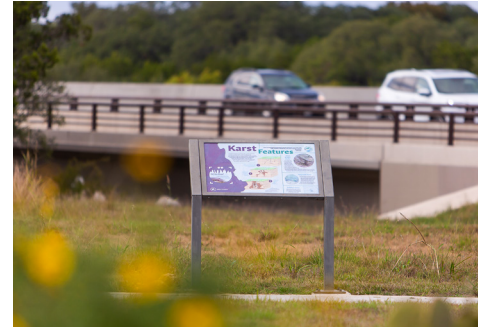
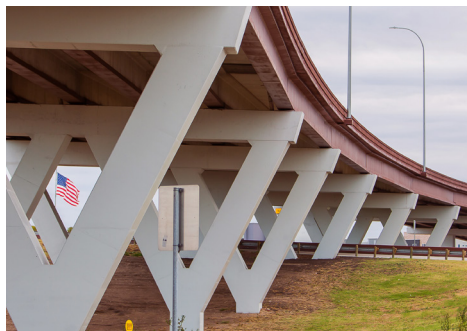
1.3.5. SH 45 SOUTHWEST

The Mobility Authority constructed, operates and maintains SH 45 Southwest, a tolled facility stretching from State Loop 1 (MoPac) to FM 1626 in southern Travis and northern Hays counties with 5.2 miles of improvements. The corridor, which opened to traffic in 2019, includes two tolled lanes in each direction and a 4.9-mile shared use path. The facility was built without frontage roads to limit impacts to the surrounding environment. The road offers drivers an alternative to congested neighborhood streets like Menchaca Road, Slaughter Lane and Brodie Lane.
